## SECTION D TROUBLESHOOTING ACCORDING TO FMT STATUS LINES

This section is intended to be used when a problem occurs during operation and a reject code is sent from the formatter (FMT) to the host/controller. The user can then refer to the reject code table, that reference the associated troubleshooting flow chart. Because the error could result from an operator mistake or a problem in the MTU, the user should evaluate the quickest method to correct the problem. All PCAs described in this section are located in the FMT unless otherwise noted.

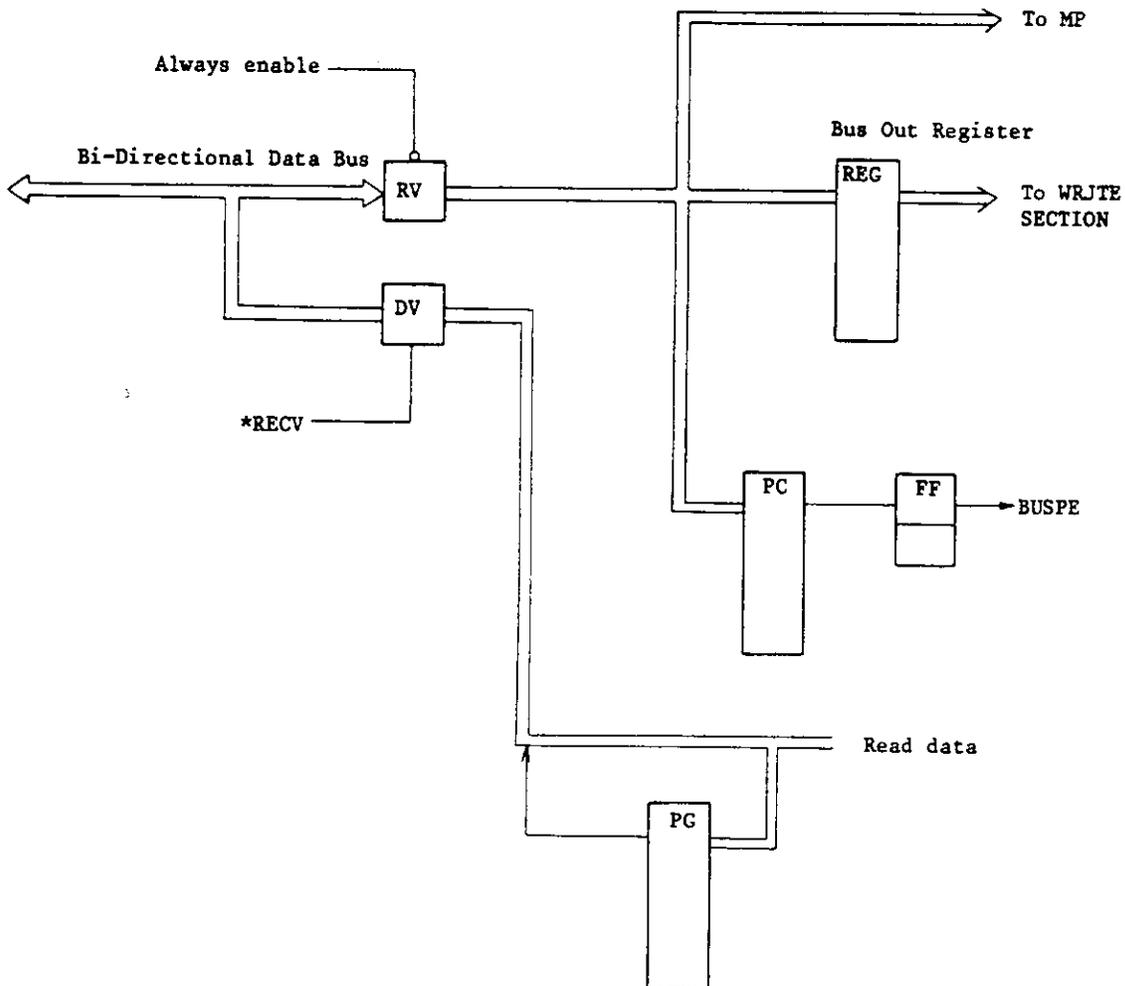
Figure D.1 Data bus parity error detection circuit

Parity error is detected in transferred data from or to the controller through bi-directional data bus.

(1) Write or loop-write-to-read command:

Data transferred from the controller is checked at the receivers of bi-directional data bus. The check timing is the same as data setting timing to bus out register. If this error occurs, data check will be set. MUX byte 1; bit P, CRC ERROR, and bit 3, MISC DATA ERROR will be set.

(2) Read or read backward command:

Read data transferred from the FMT is checked through receivers at the reading edge of TRAK signal. Generated parity bit is added to the input data to the drivers of bi-directional data bus.

(3) SDIA command:

Diagnostic flag bytes transferred from the controller is checked in the same manner as the write command. It is checked when TREQ and TRAK signals are asserted.

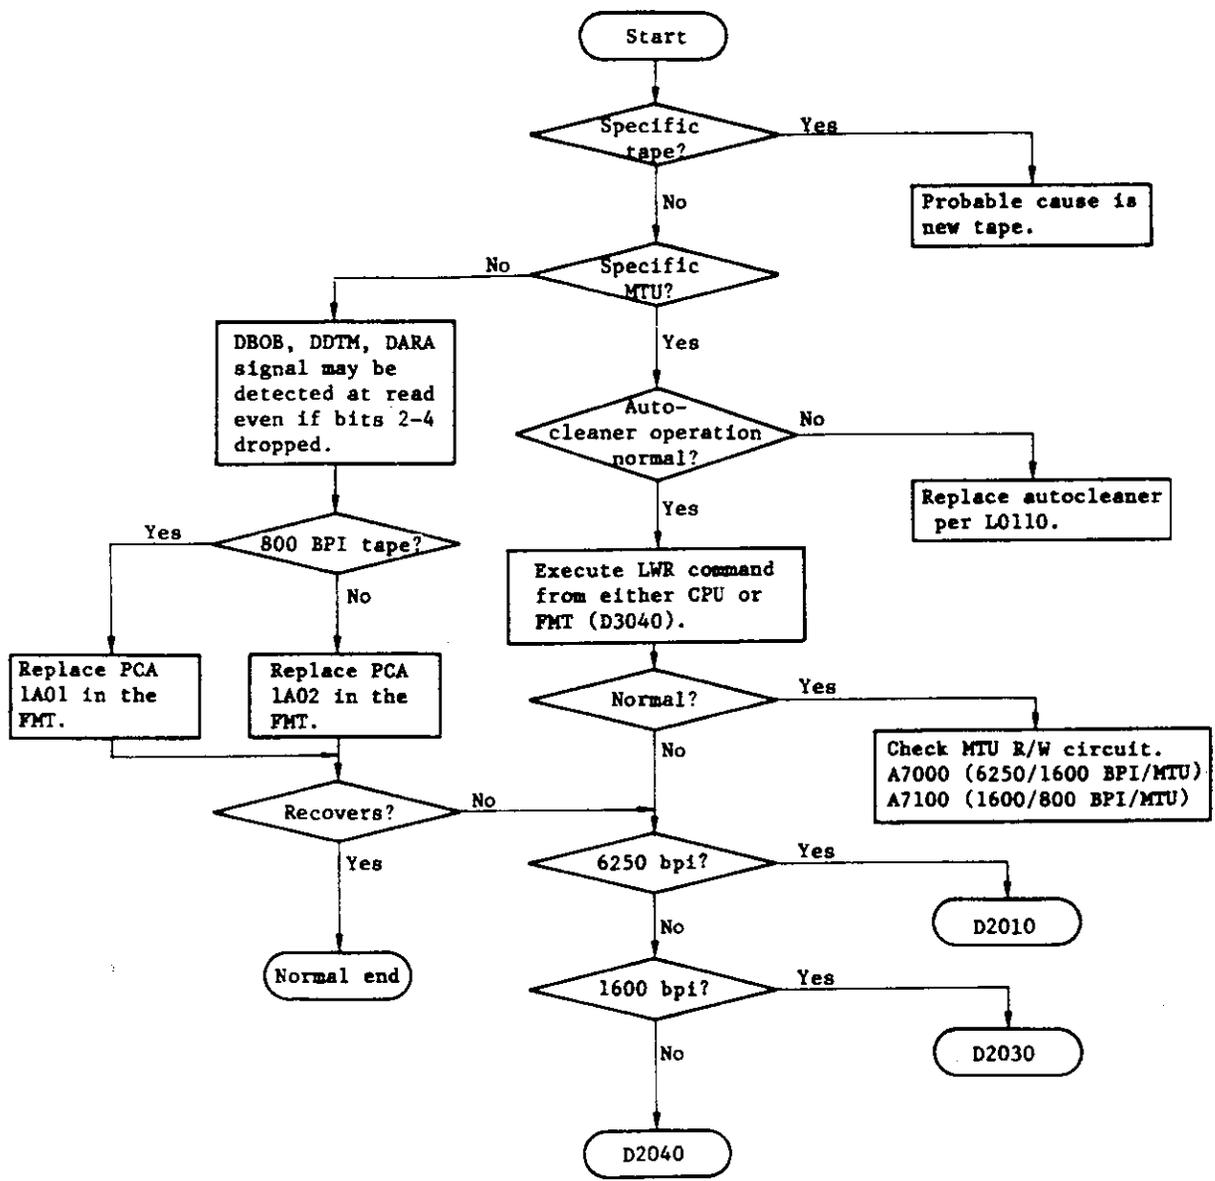
D0060 20-Meter Check (Reject Code 025)

This check is generated when any data was not detected for more than 20 m at read command. (BOB, DTM, ARA, or NRZ data byte was not detected.)

- Notes:
- (1) DBOB = Detection of beginning of block.
  - (2) DARA = Detected automatic read amplification.
  - (3) DMT = Detected tape mark.

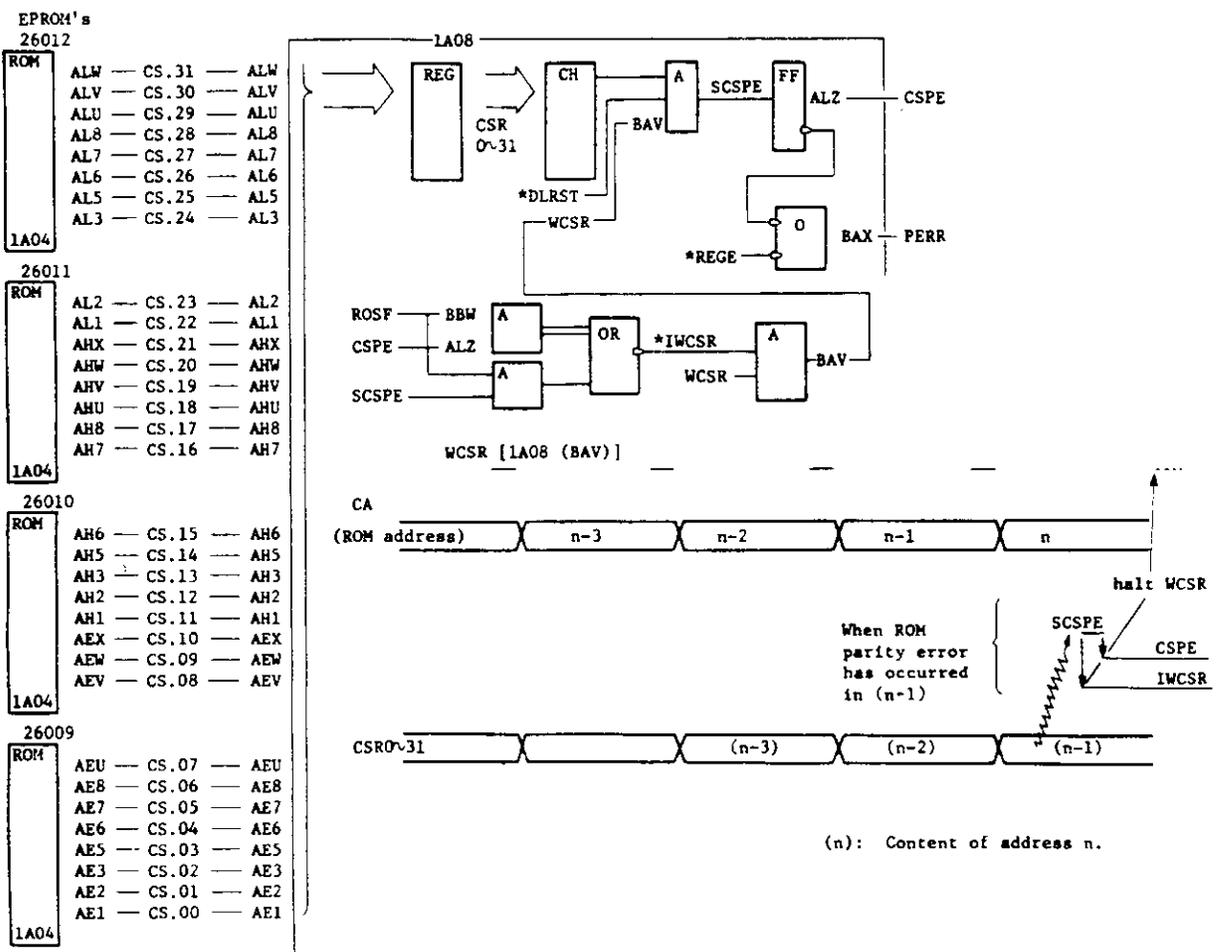
Figure D.2 ROM parity error troubleshooting

D1011 ROM Parity Error (Reject Code 002)

Use ROM scan function with field tester as follows:

- (1) Set ONL/OFL switch to OFL.
- (2) Set switches S0 through S7 to \$F4, then toggle the CNT. The ROM scan function begins.
- (3) Set switches S0 through S7 to \$A4, and lamps L0 through L11 will be in a half-lit condition if a ROM parity error has not occurred. When a ROM parity error occurs, microprocessor is halted immediately.
- (4) Set switches S0 through S7 to \$F0, then toggle the CNT to terminate the ROM scan function. Return the ONL/OFL switch to ONL after all troubleshooting.

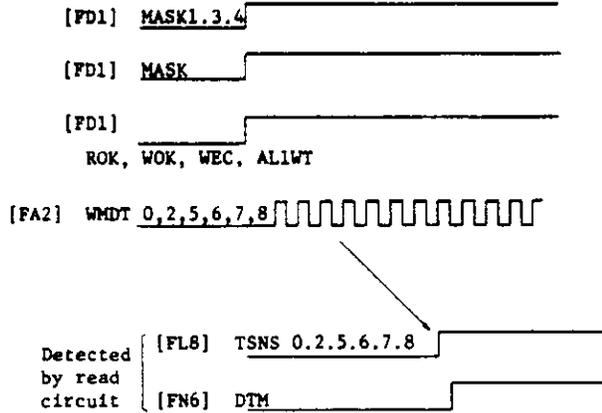
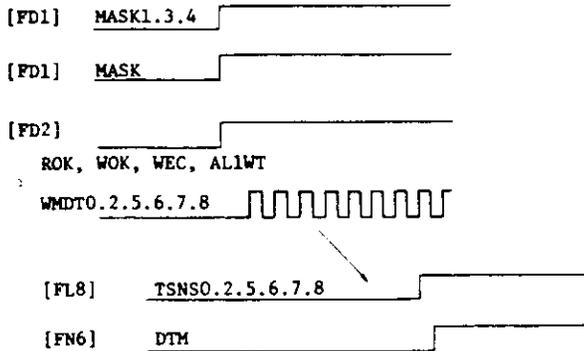
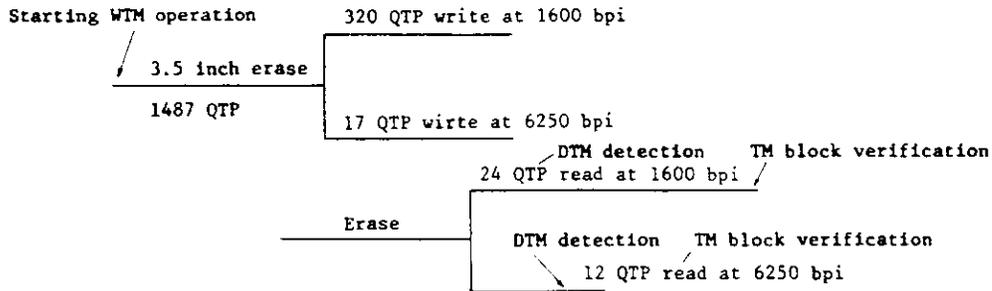
Figure D.3 Write tape mark error troubleshooting (6250 and 1600 bpi)

This error occurs when TM (Tape Mark) is written incorrectly as follows:

- (1) When the TM pattern cannot be detected within the specified length from the end of recording the TM block in 6250/1600 bpi operation.
- (2) When IBG cannot be detected within the specified length from the end of the TM block in 6250/1600 bpi operation.
- (3) When the TM code cannot be detected in 800 bpi operation.

**D1221 Write Tape Mark Error - 2**

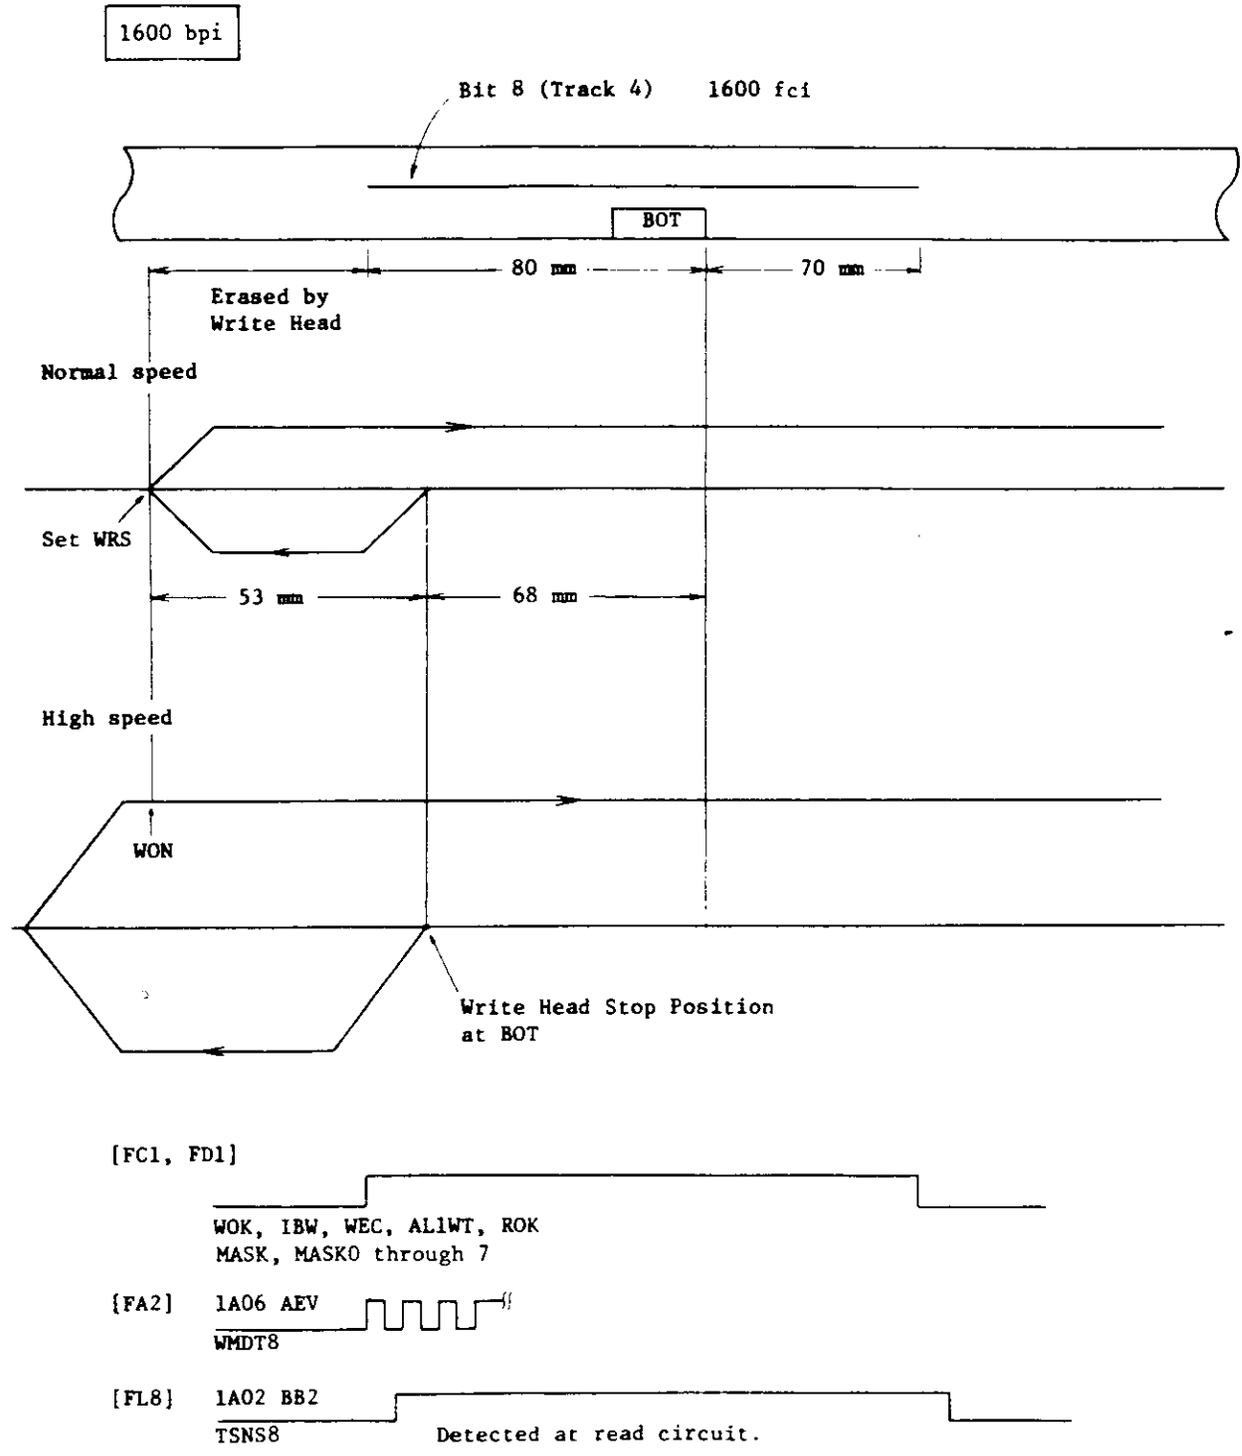
Figure D.5 ID burst check (1600 bpi)

ID burst check is generated when recording density identification (ID), ARA, and IVTM (ARA ID) are written incorrectly, as described below.

- (1) ID burst could not be detected.
  - 6250 bpi - track 6 (bit 1)
  - 1600 bpi - track 4 (bit 8)
- (2) ARA burst was written incorrectly (D1260).  
SAGC check (sense byte 8, bit 4) is set.
- (3) IVTM could not be detected.

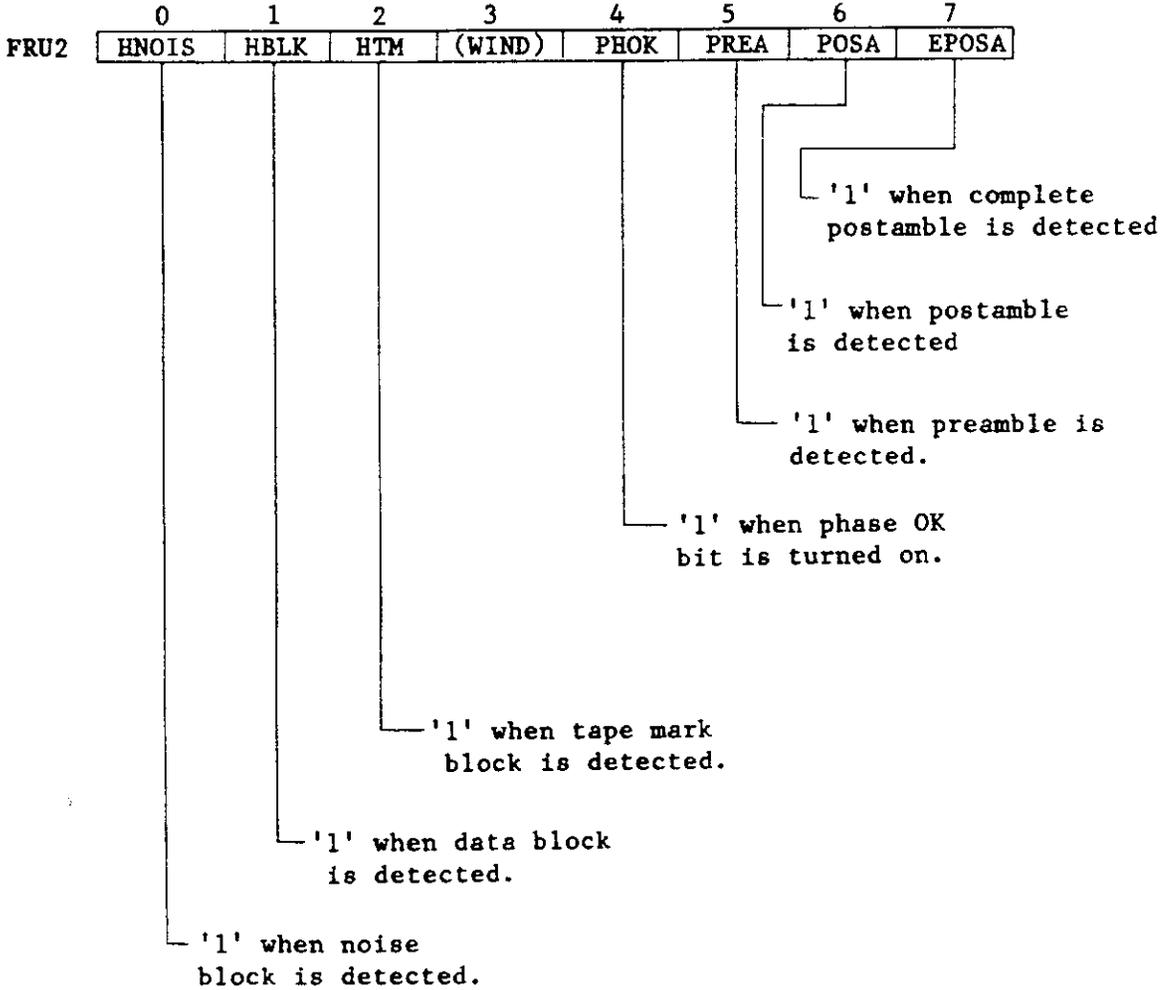
D1250	IBG Detected
-------	--------------

An error will be generated when an inter-block gap (IBG) is detected during write or loop write-to read operation. The data check line bit is asserted in this case. EVC (DSB12, bit 1) may also be set in 6250/1600 bpi write operation. The following FRUs may be indicated on DSB 14, 15.

- Notes:
- (1) FRU = Field replaceable unit.

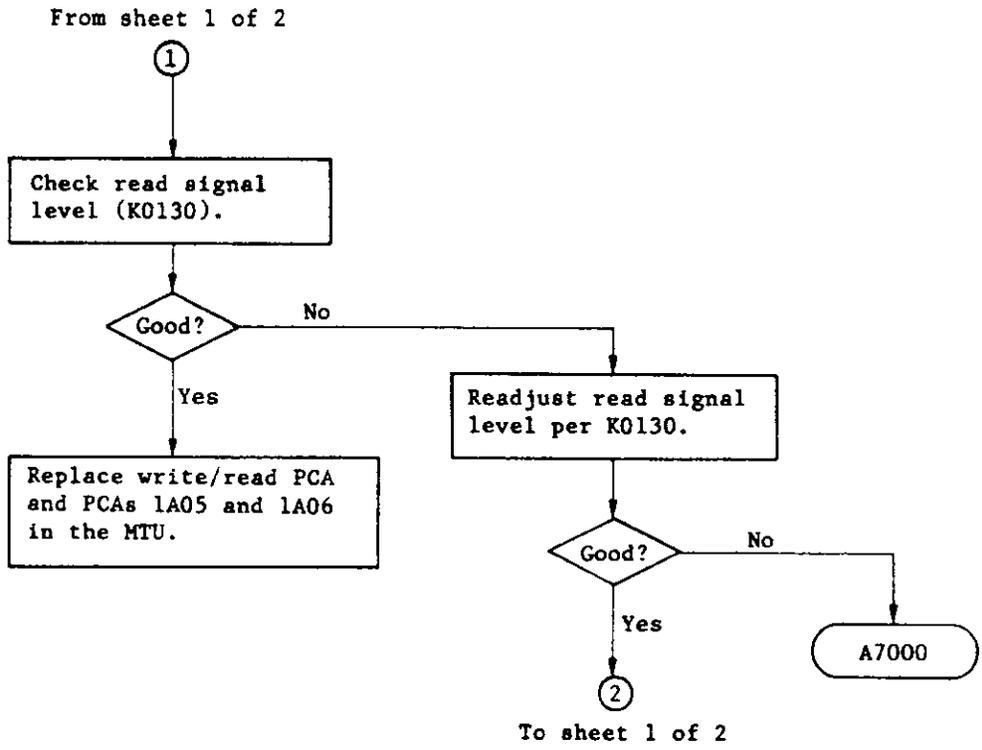
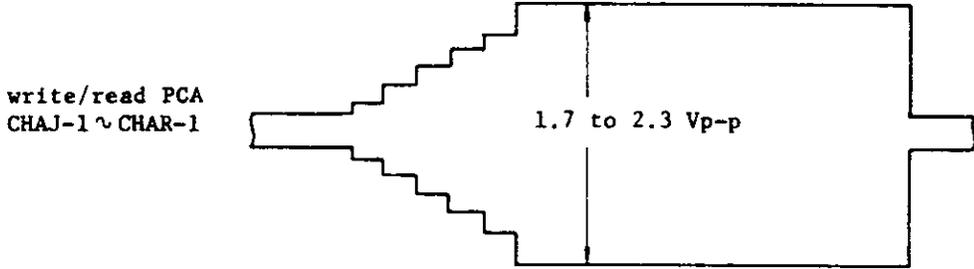
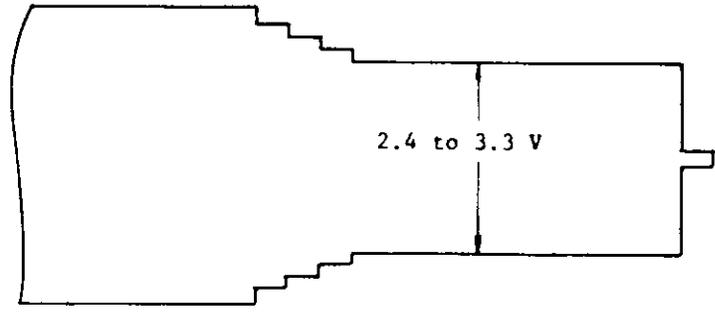
Figure D.7 SAGC and GSD waveform

Self-adjust gain control (SAGC) check is generated when automatic read amplification (ARA) burst read or write was performed incorrectly during 6250 bpi operation.

(a) SAGC waveform

(b) GSD waveform

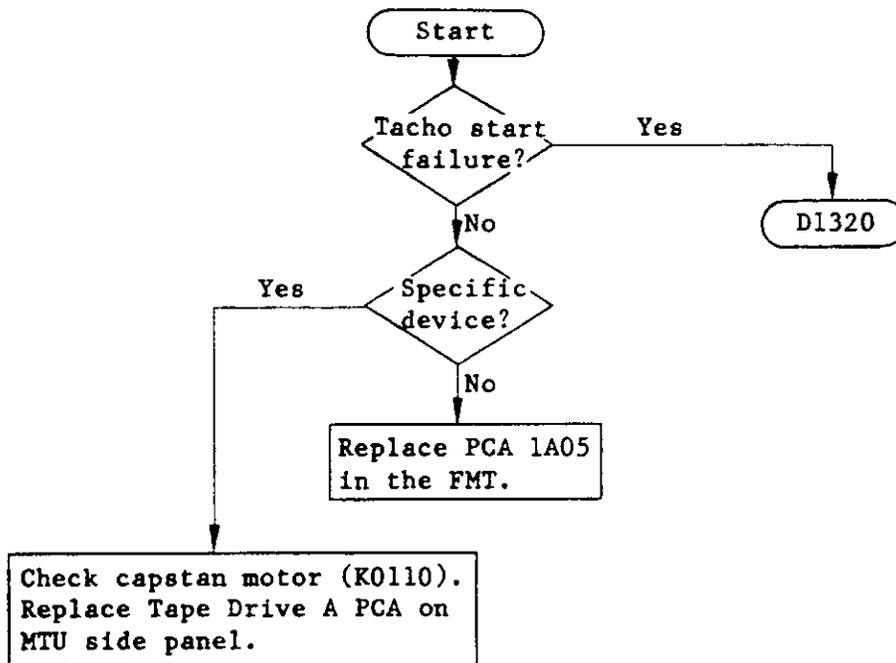
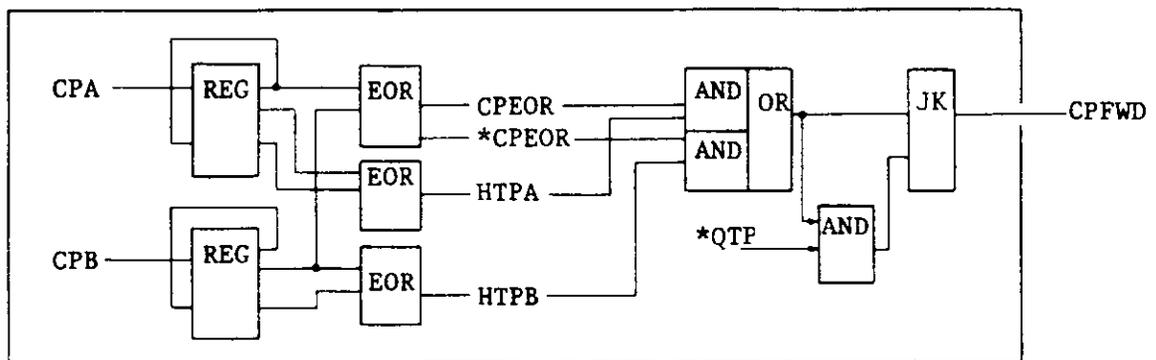
Figure D.8 Reject code 233 troubleshooting

D1310	Reject Code 233
-------	-----------------

- (1) The tape is operated more than the prescribed QTP (quarter tacho pulse) number in reverse direction at MTU starting.
  - o FRU1 (sense byte 14) .... CC
  - o FRU2 (sense byte 15) .... TQP count number (length of running of drive direction.)
- (2) Error when operated 108TP in reverse direction.

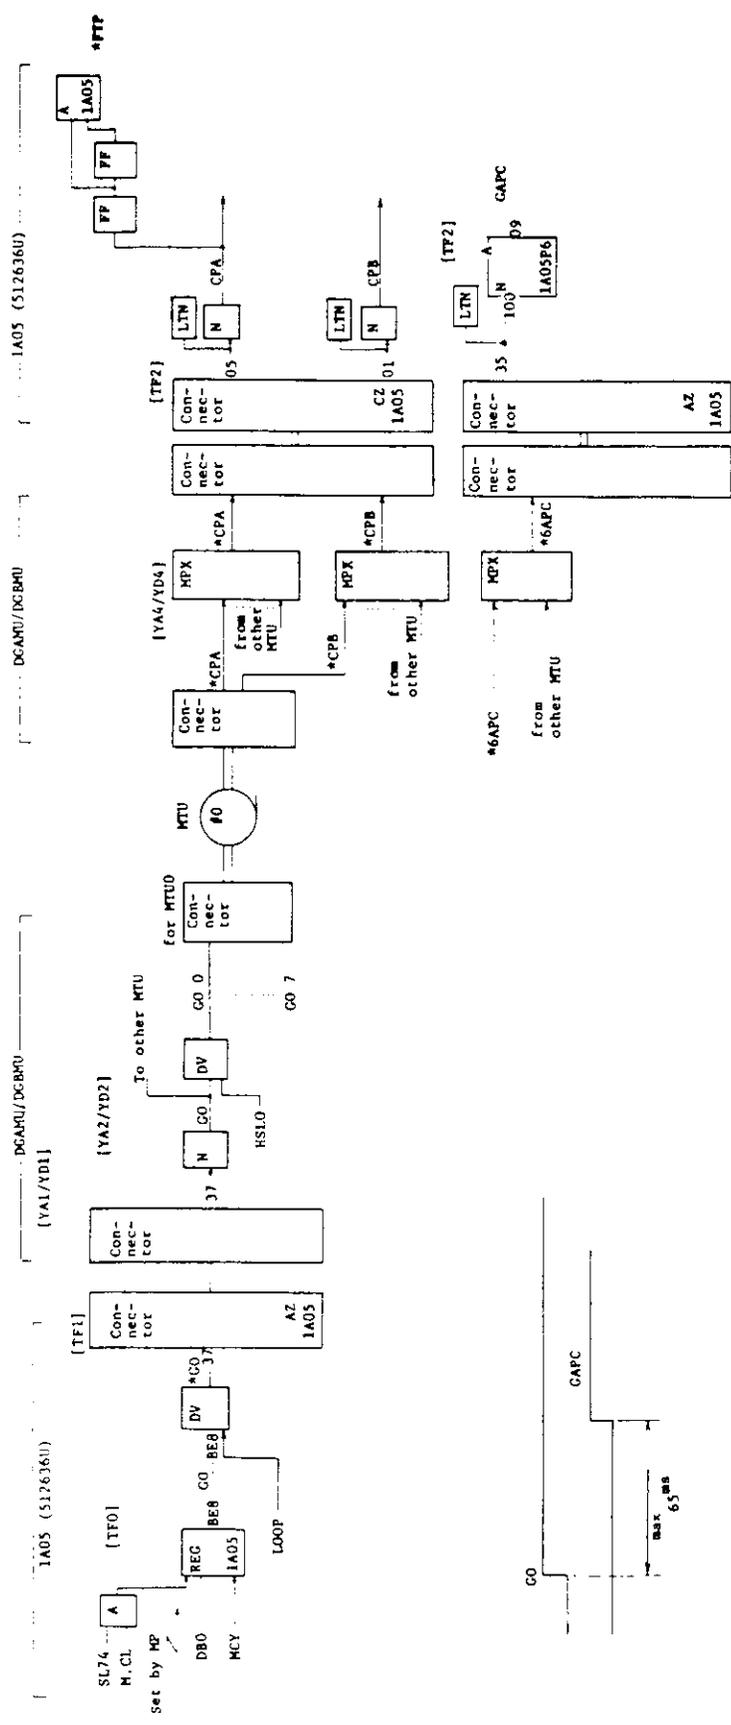
Figure D.9 Tacho start circuit

D1320 Tacho Start Failure - 1 (Reject Codes 032, 012)

- (1) Reject code 032  
 When prescribed QTP length is not detected within the prescribed time after MTU start.  
 FRU1 (SB14) .... 108-QTP count total (drive direction and reverse direction)  
 FRU2 (DSB15) .... 20-drive direction QTP count
- (2) Reject Code 012  
 when GAP CTL is not detected within prescribed time after MTU start.  
 FRU1 .... 108-QTP spacing  
 FRU2 .... 00  
 Prescribed time .... 65 ms

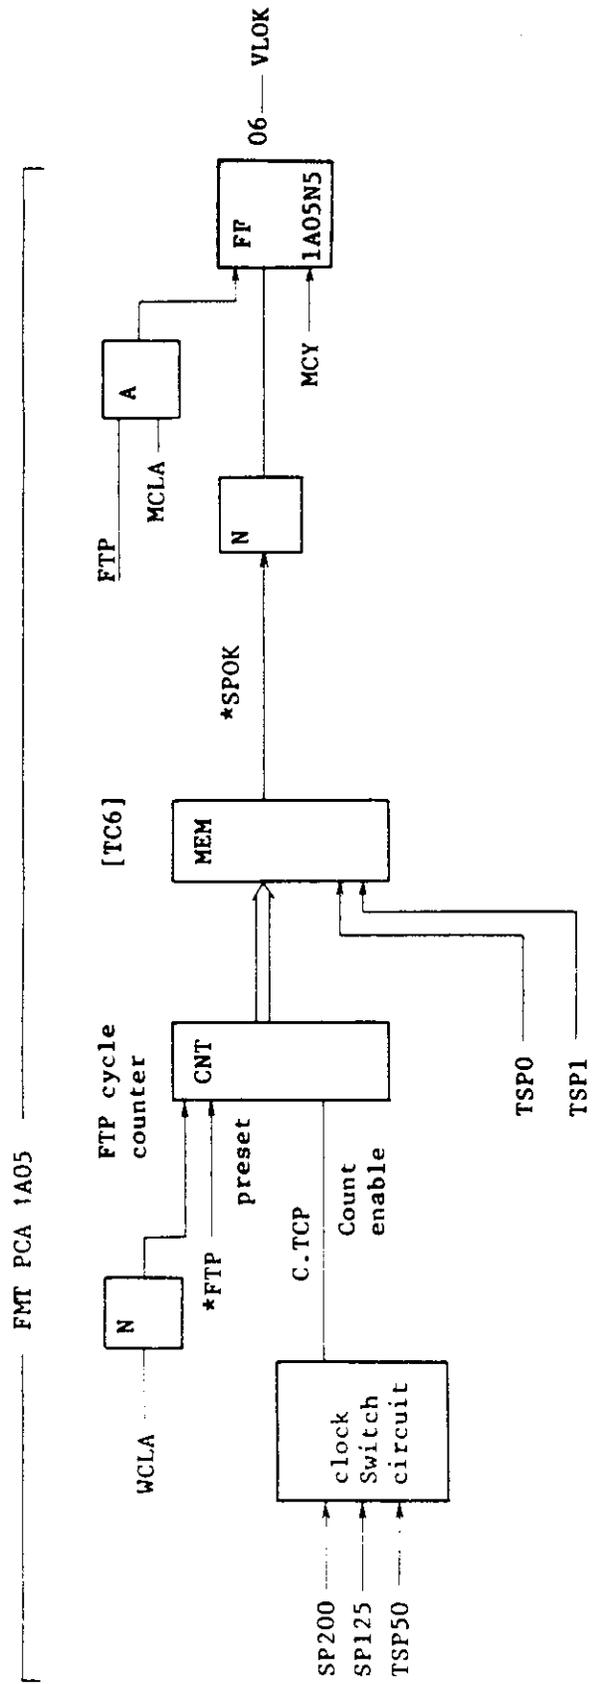
Figure D.10 Velocity check circuit

D1330 Velocity Check - 1 (Reject Code 112)

This error will be generated when velocity retry (over 16 times) has occurred during write operation. Velocity retry - DSB 12, bit 4. Write start was late because capstan speed was not within  $\pm 7$ .

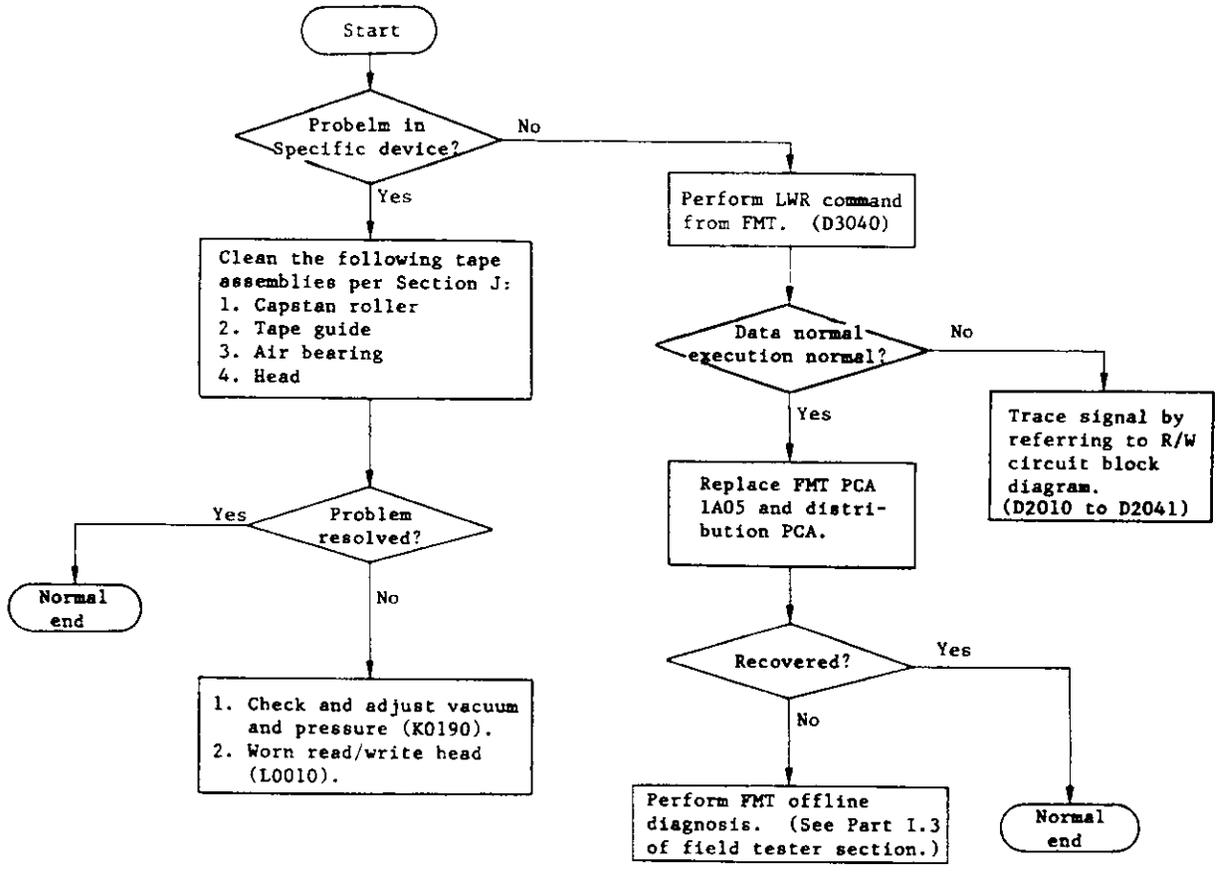
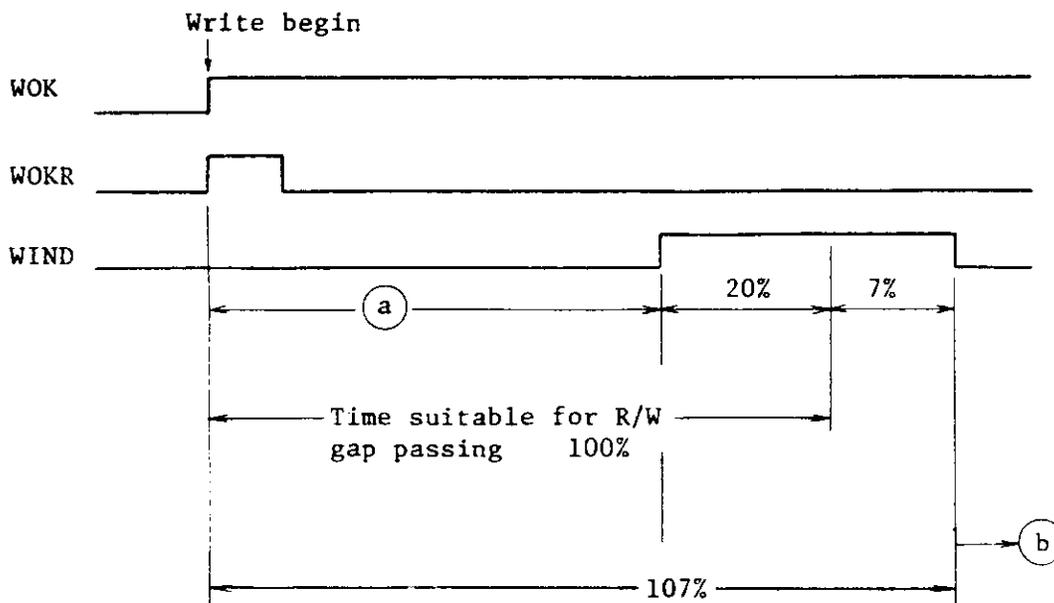
Figure D.11 Slip check timing

D1350 Early Begin, Slow Begin, and Slow-End Read Back Check

- Early begin read back check (DSB11, bit 4)  
Error is generated in the following cases:
  - (1) When data-byte (800 bpi) or DBOB pattern (1600/6250 bpi) is detected within time (a) (see Figure D.11) at write command execution. (Data is detected too early.)
  - (2) When IBG is detected during writing (WOK signal on) at 800 bpi (IBG detected too early).
- Slow begin read back check (DSB11, bit 2)  
Error is generated when data-byte (800 bpi) or No. 5 pattern (1600/6250 bpi) is detected within time (b) (Figure D.11). (Data is detected too slow.)
- Slow end read back check (DSB11, bit 1)  
Error is generated when IBG is detected at over 70 QTP after block end detected after write end.

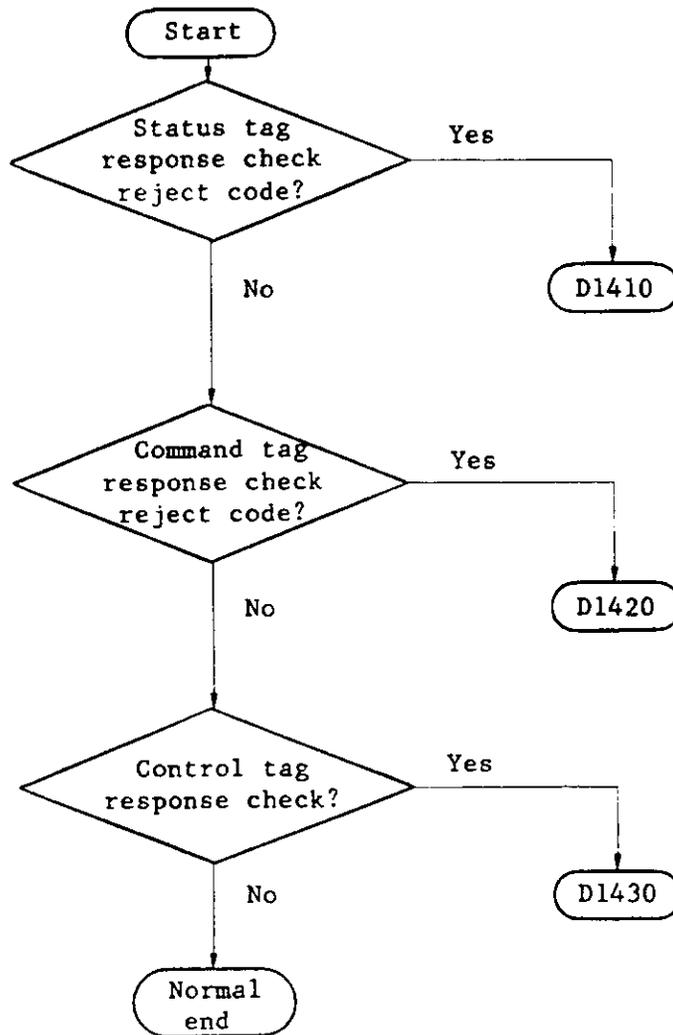
The FMT uses three tag signal lines (Status tag, Control tag, and Go tag) to control the MTU. The FMT uses the status tag line in conjunction with the control tag line as a command tag line when both the status and the control tag lines are activated.

When the FMT uses the status tag, control tag, and command tag lines to control the MTU, the FMT receives a response from the MTU. When the response is not normal, the status tag response check, control tag response check, and command tag response check are set.

FRU1 (DSB14) ... Control data  
(Content of DVBO register)  
FRU2 (DSB15) ... Response data  
(Content of DVBO register)

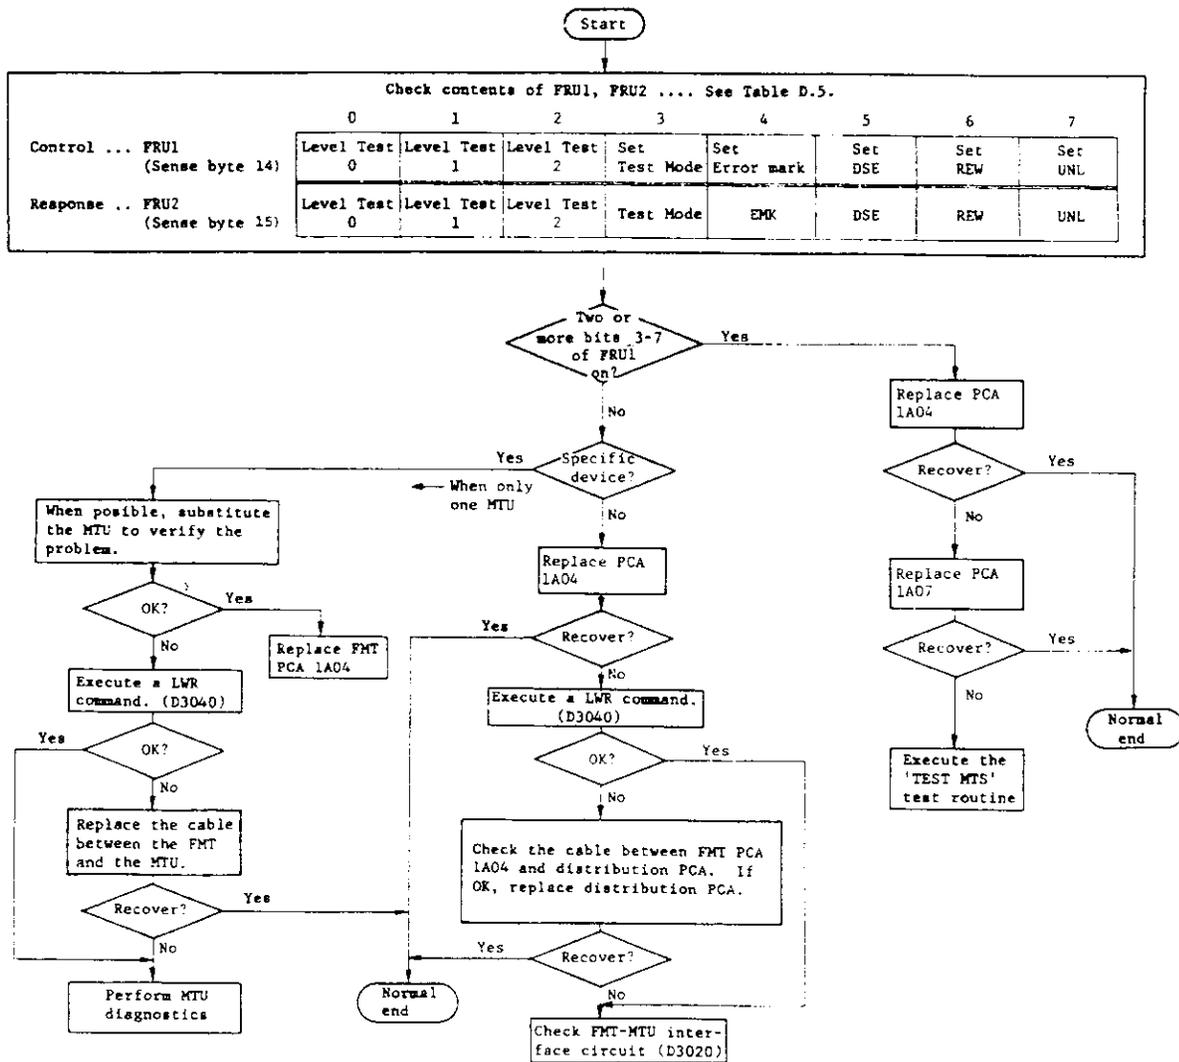
**D1430 Control Tag Response Check**

Table D.5 Response check with Control Tag

Control FRU1	Function	Response (FRU2)	Time out
bit 0 ~ bit 2	Level set	Level Test 0~2	500 ms
bit 3	Set Test-Mode	Test Mode	500 ms
bit 4	Set EMK	EMT = 1	500 ms
bit 5	Set DSE	DSE = 1 (also READY = 0)	500 ms
bit 6	Set REW	REW = 1 (also READY = 0)	500 ms
bit 7	Set UNL	UNL = 1 (also READY = 0)	500 ms

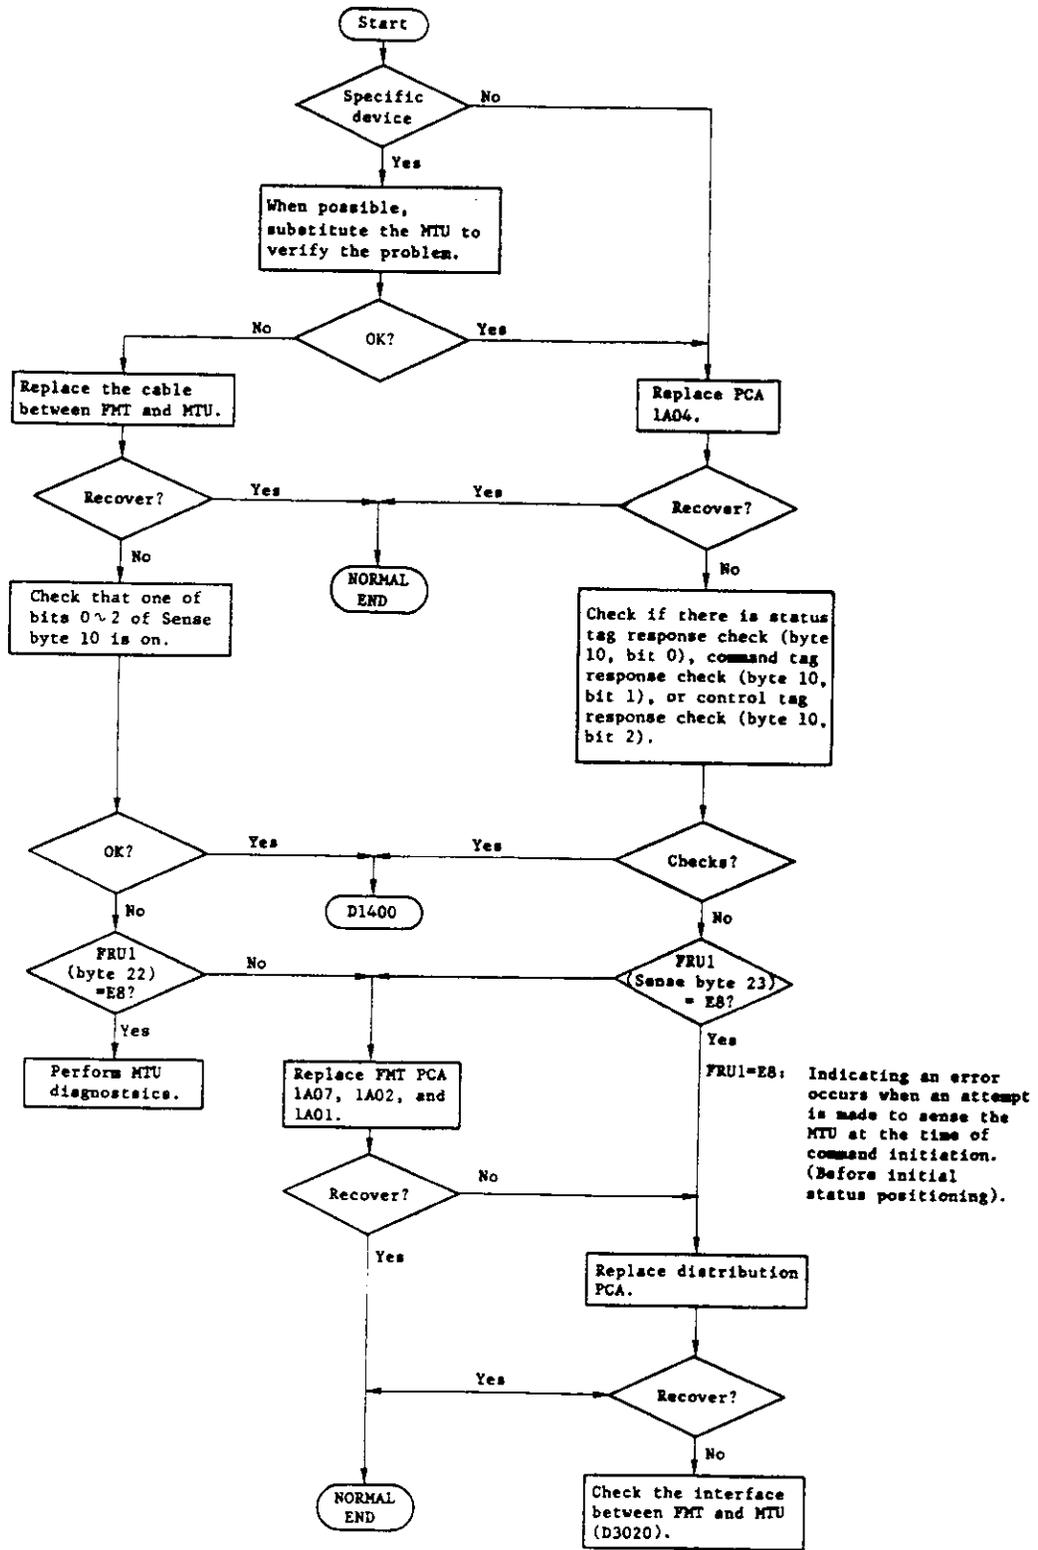
**D1440 Tag In Check**

Error is generate when TAG-IN signal response does not arrive from MTU within the prescribed time.

(Prescribed time = 3 through 7  $\mu$ s)

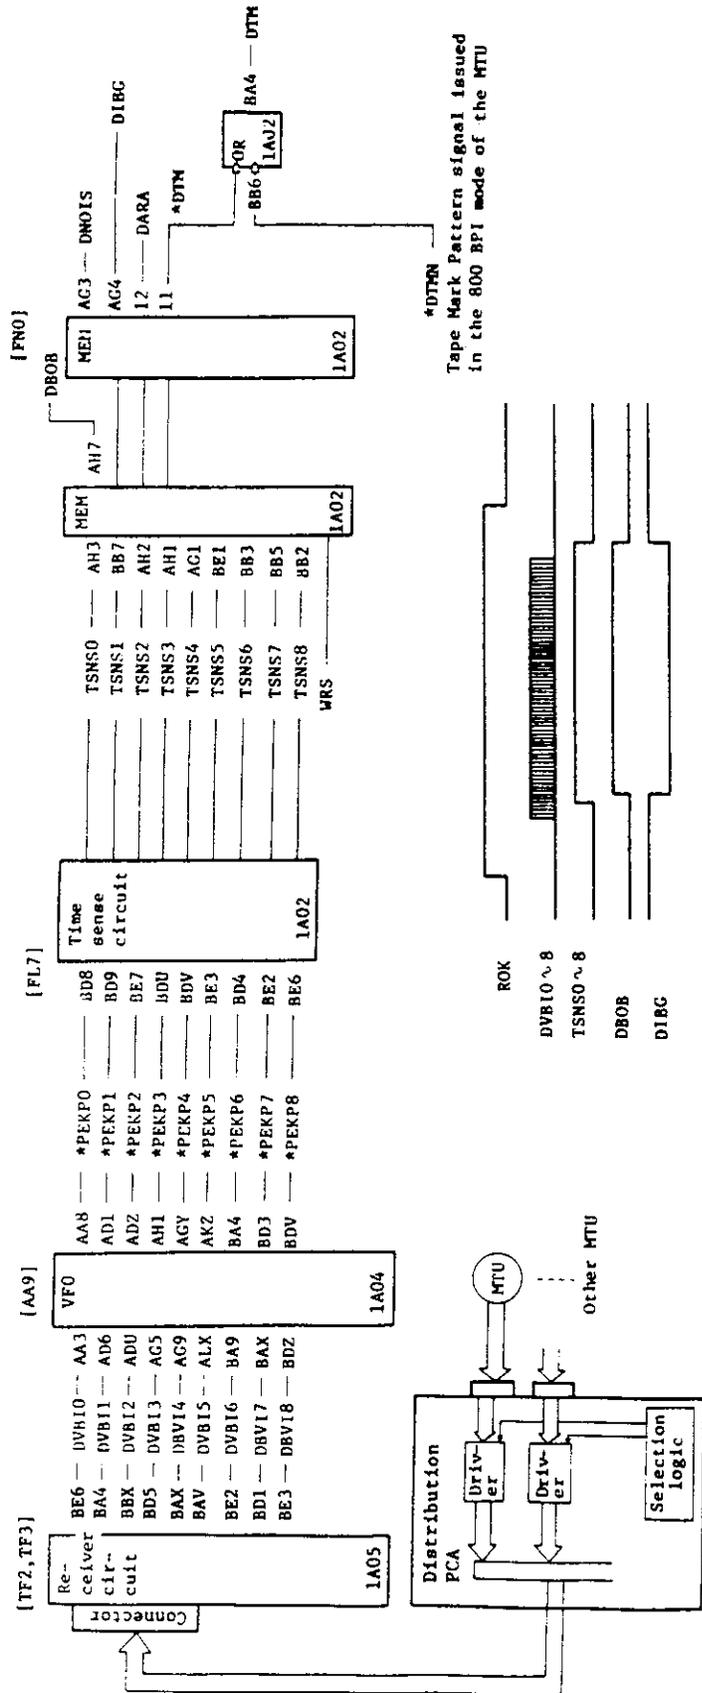
Figure D.12 Time sense decode circuit

D1453 Time Sense Decode Circuit

\*DTMN  
Tape Mark Pattern signal issued  
in the 800 BPI mode of the MTU

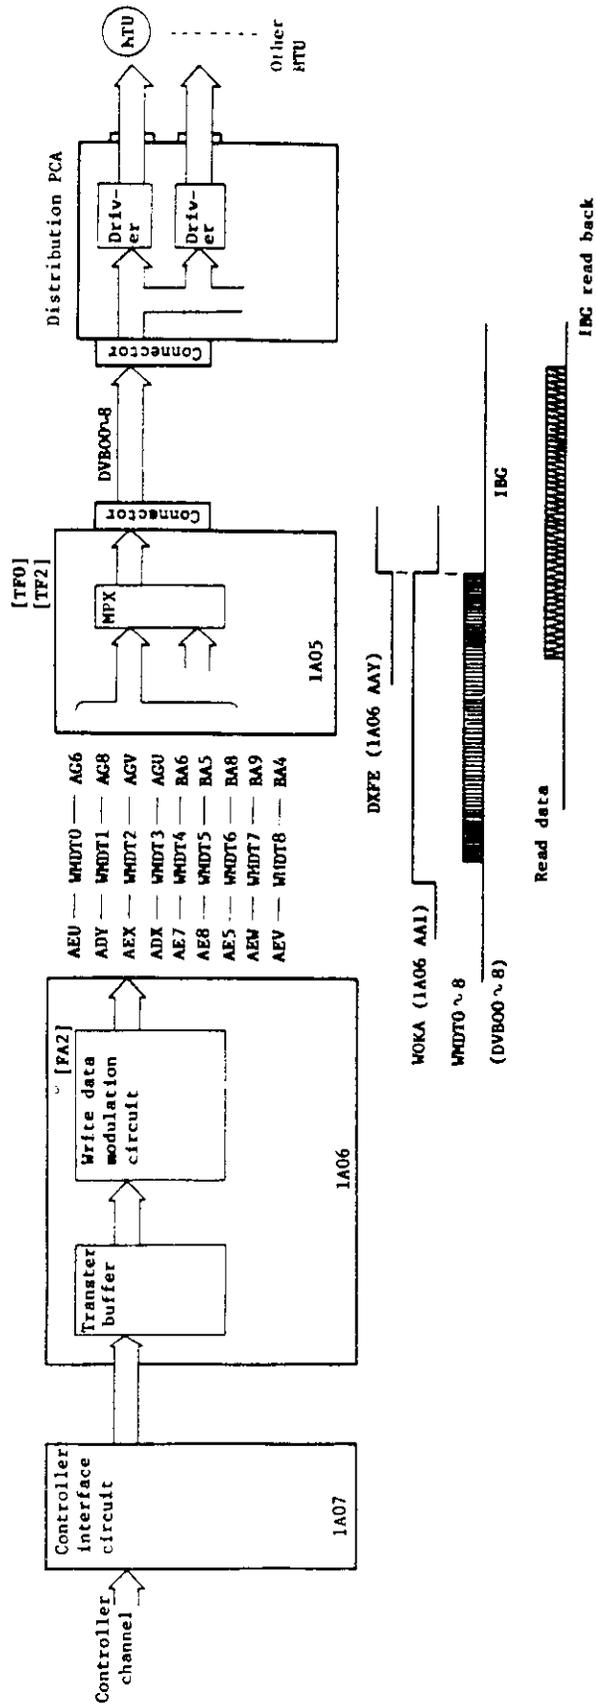
Figure D.13 Write data circuit

D1454 Write Data

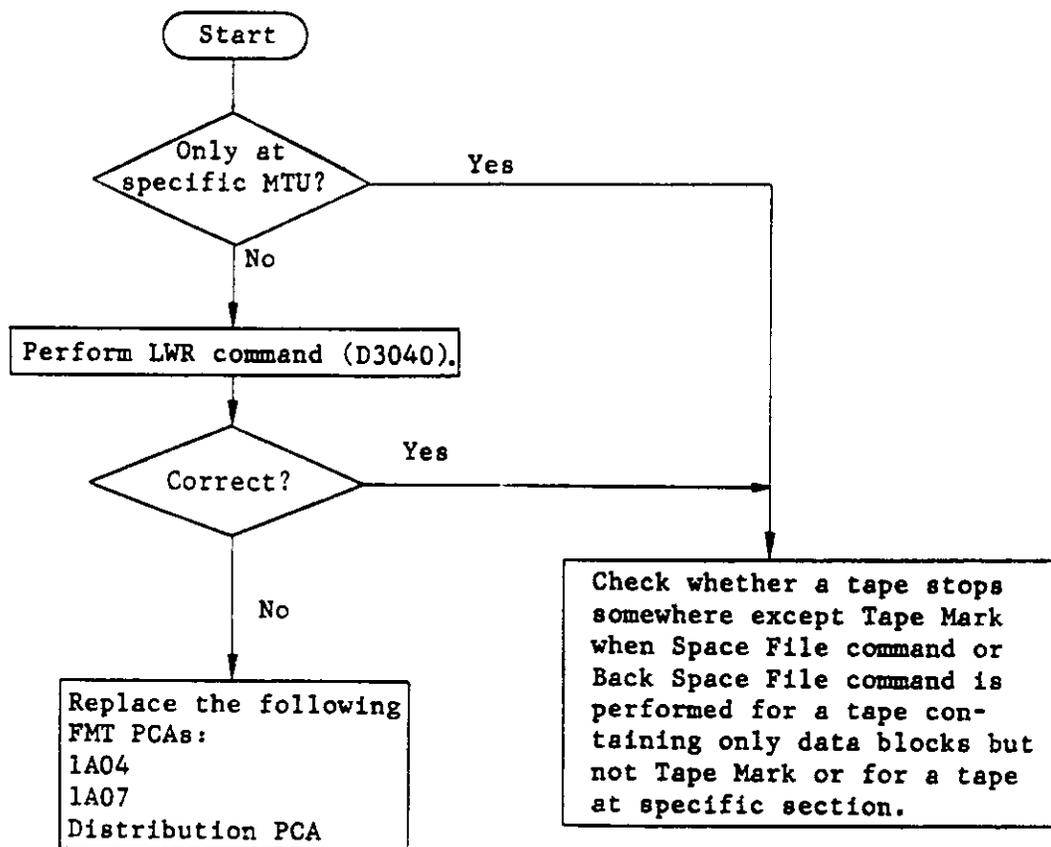
D1465 Missing Tape Mark (Reject Code 310)

After instructing MTU to search for Tape Mark Search in order to perform Space File or Back Space File command an error occurs:

- 1) When Tape Mark block cannot be detected correctly, though MTU enters ready status.  
(Bit 7 of TU sense byte, (Tape Mark) is 0.)
- 2) When MTU detects an interruption (except BOT detection and Tape overrun of the MTU).

Note: In this case, RWTO (Sense byte 11, bit 0) is also generated.
